Manhole Inspection Summary

Manhole # S43I__015MH

Location Address: **side 300-318 mason ct**

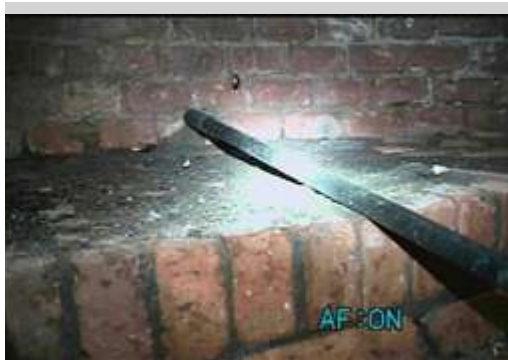
Misc-2

bench debris

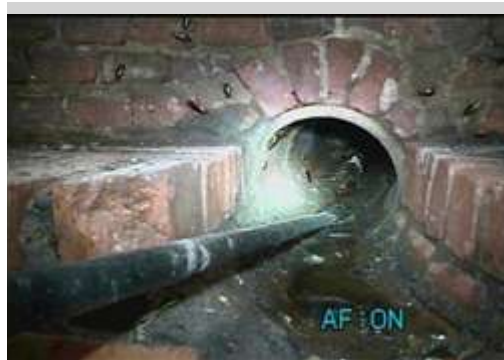
Misc-1

channel debris

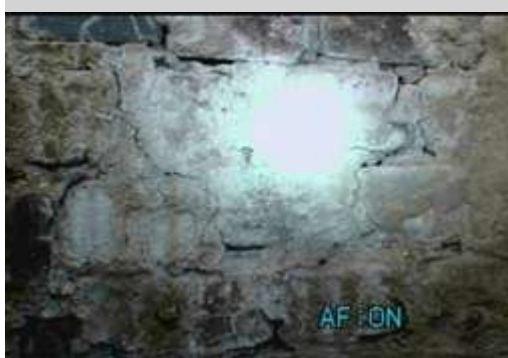
Defect 2

Condition: ☐ Sound ☒ **Cracked** ☐ Root Intrusion ☐ Loose Brick ☒ **Deteriorated**

cracked & deteriorated corbal

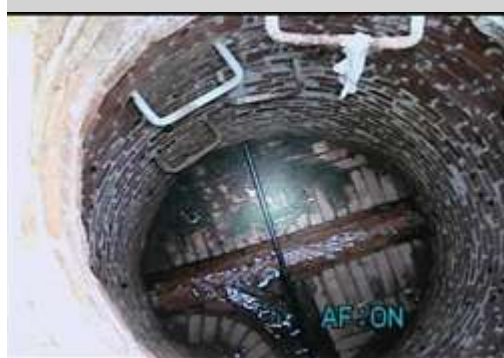
Defect 1

Count: **4** Missing: **0** ☒ **Corroded**

steps

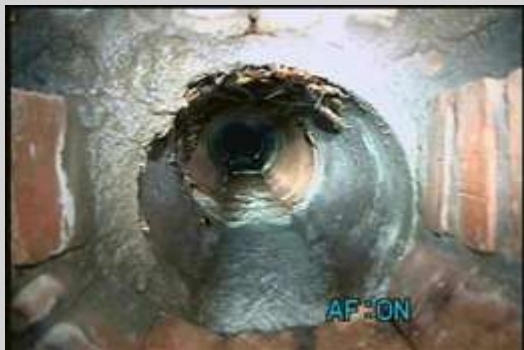
12 O'Clock Outflow

8 in. Circular Gravity Sewer
Pipe Out @ 12 O'Clock

Deposits: ☒ None ☐ Mud ☐ Sludge ☐ **Debris** ☐ Grease

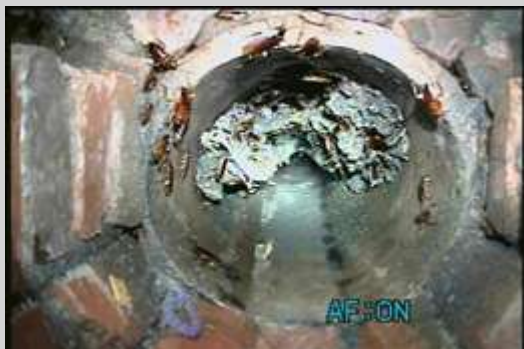
6 O'Clock Inflow

8 in. Circular Gravity Sewer
Pipe In @ 6 O'Clock

Deposits: ☐ None ☐ Mud ☒ **Sludge** ☐ **Debris** ☐ Grease

Silt Depth: 3.5 (in.) Deposits Extent: **Medium**

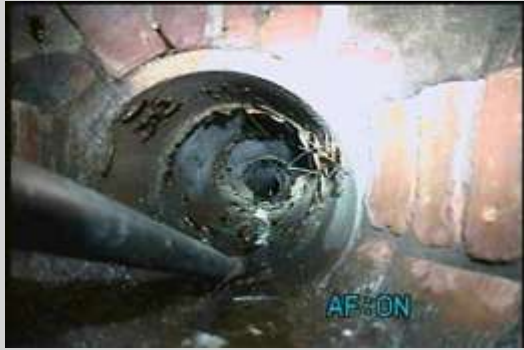
9 O'Clock Inflow

8 in. Circular Gravity Sewer
Pipe In @ 9 O'Clock

Deposits: ☐ None ☐ Mud ☐ Sludge ☒ **Debris** ☐ Grease

Silt Depth: **0** (in.) Deposits Extent: **Light**
